### PIP5829 MIL Illuminated with DTC P0299

#### Models

Brand:	Model:	Model Years:	VIN:		Engine:	Transmissions:
			from	to		
BUICK	Encore GX	2019 - 2022	All	All	1.2L (LIH)	All
CHEVROLET	Trailblazer	2020 - 2022	All	All	1.2L (LIH)	All

Involved Region or Country	North America
Condition	MIL illuminated with DTC P0299
Cause	Potential turbocharger wastegate linkage wear

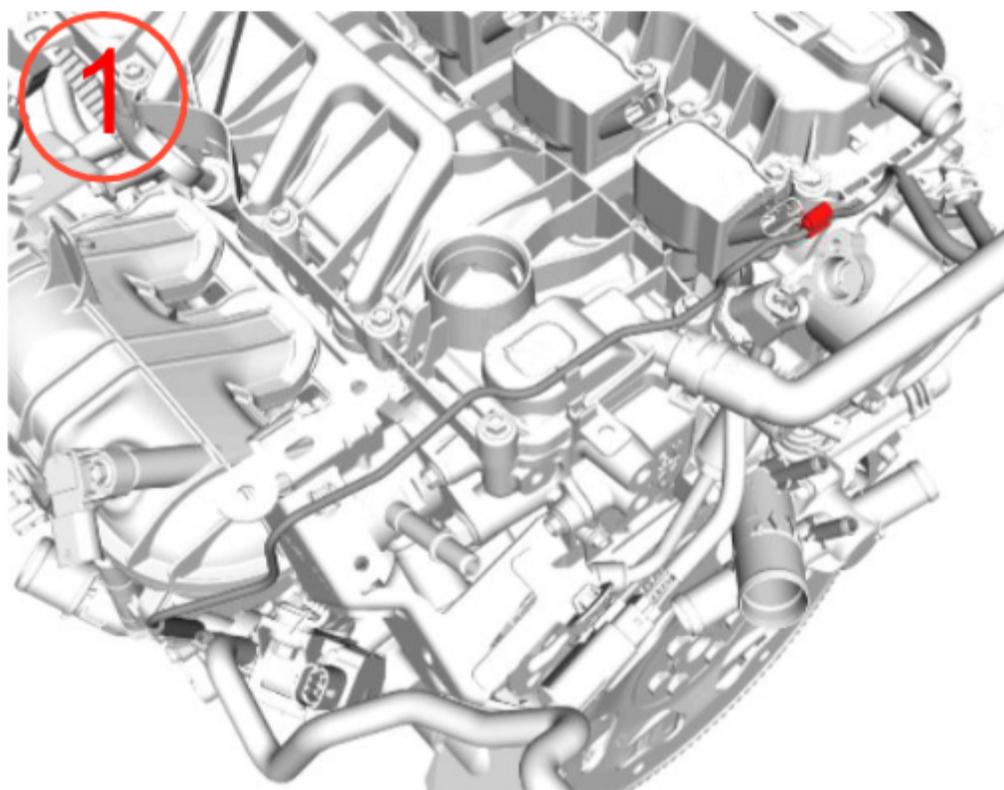
Disconnect the Turbocharger Wastegate Solenoid Vacuum Supply Hose (shown in fig 1 below) from the Turbocharger Wastegate Solenoid Valve.

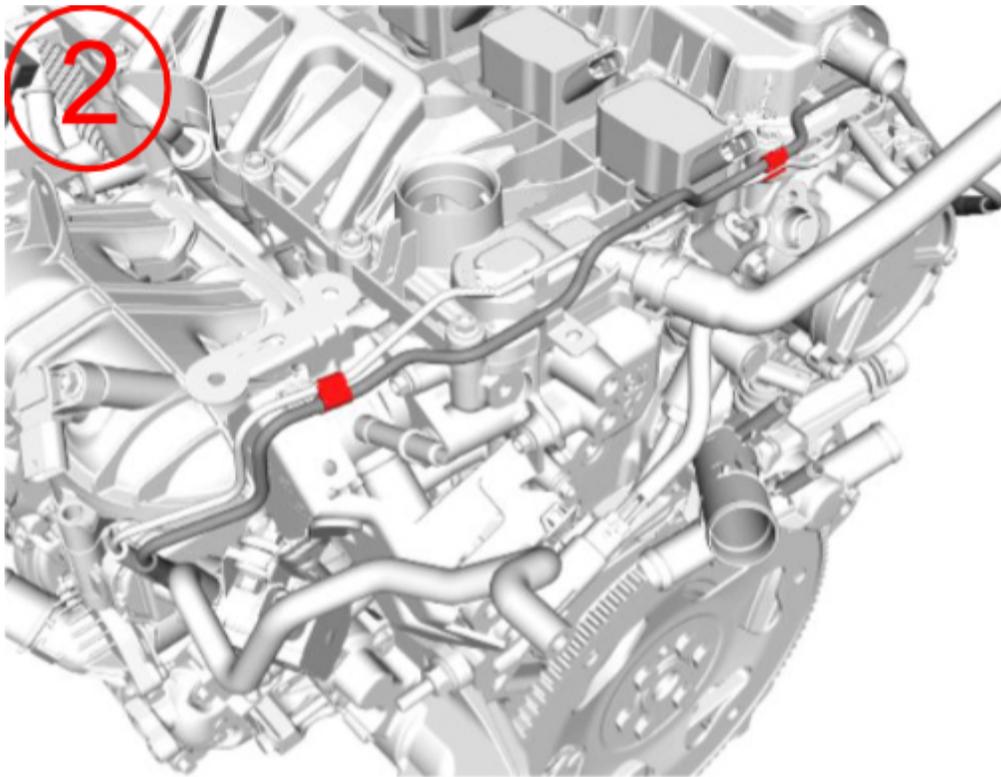
Disconnect the Turbocharger Wastegate Solenoid Actuator Supply Hose (**shown in fig 2 below**) from the Turbocharger Wastegate Solenoid Valve.
